Many of our clients, as well as engineers and architects, have been inquiring whether Silvercladd is corrosion resistant and its performance against caustic soda NaOH. Consequently, we are now able to report a case-study conducted in a real setting, to answer these questions.

Date of first installation: November 15th, 2011 Date of inspection: July 4th, 2013 Location: Italy Disclaimer: we have been requested not to mention any names as a privacy matter Can Silvercladd 800 resist caustic soda environment? You be the judge!

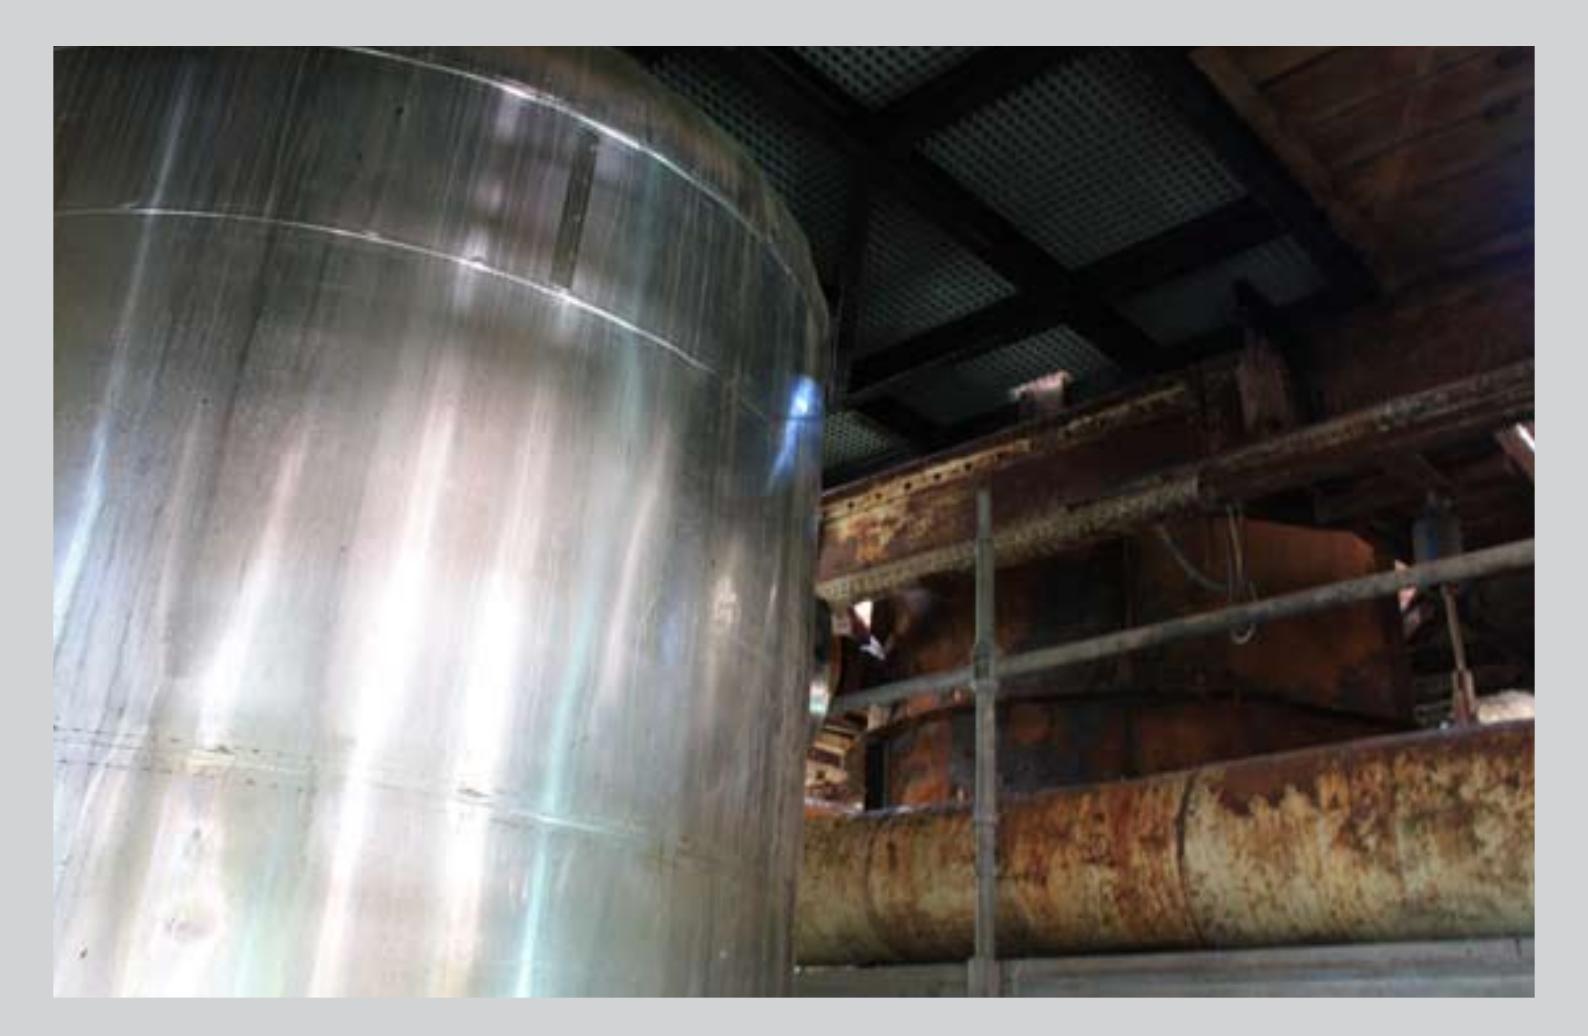
- Above: metal jacket installed about 2 years ago
 Bellow: Silvercladd 800 installed 1.5 years ago

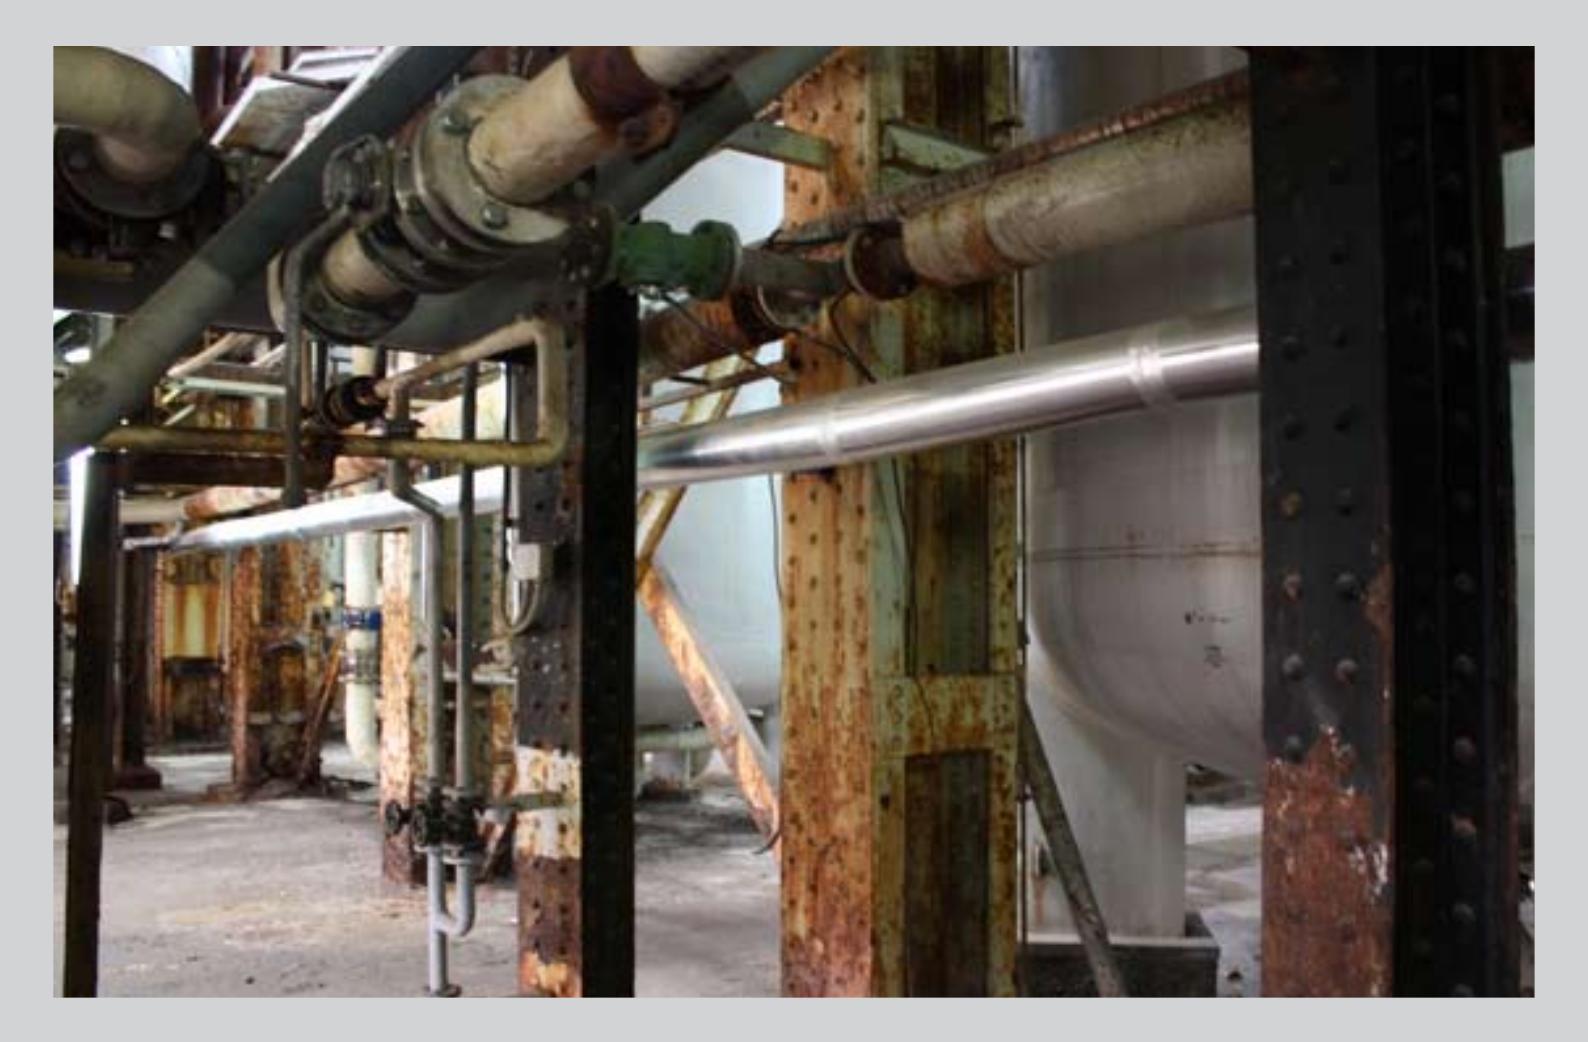
- Above: metal jacket installed about 2-3 years ago
- Bellow: Silvercladd 800 installed over pipe, over 1 year ago

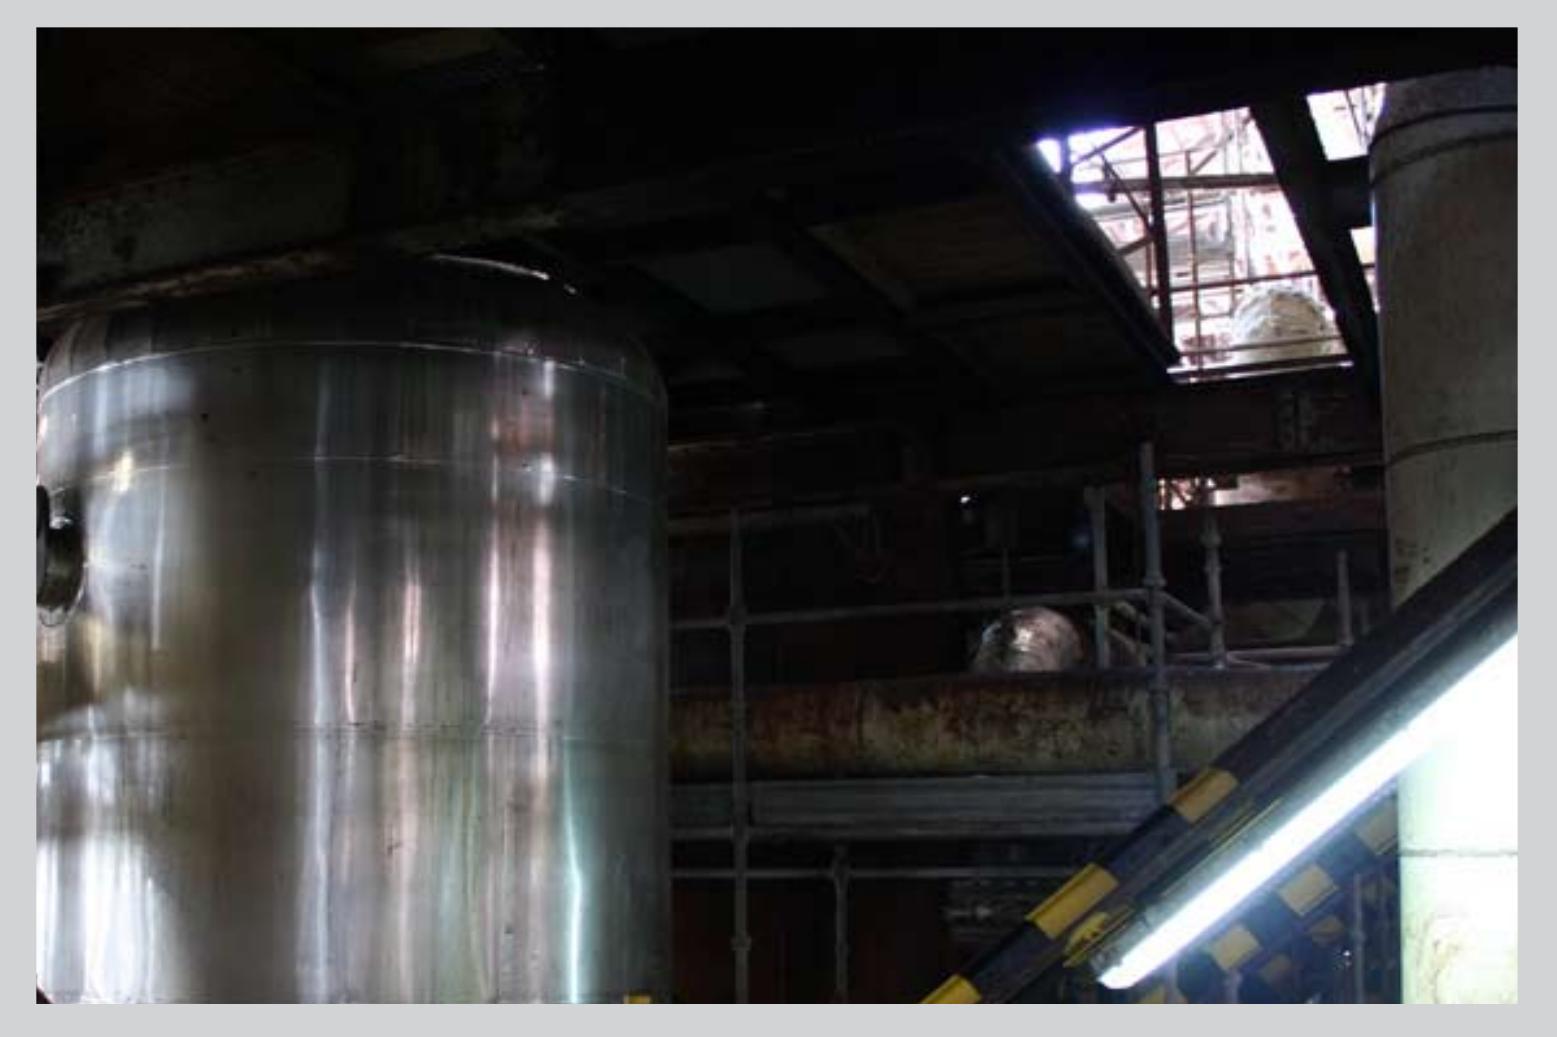
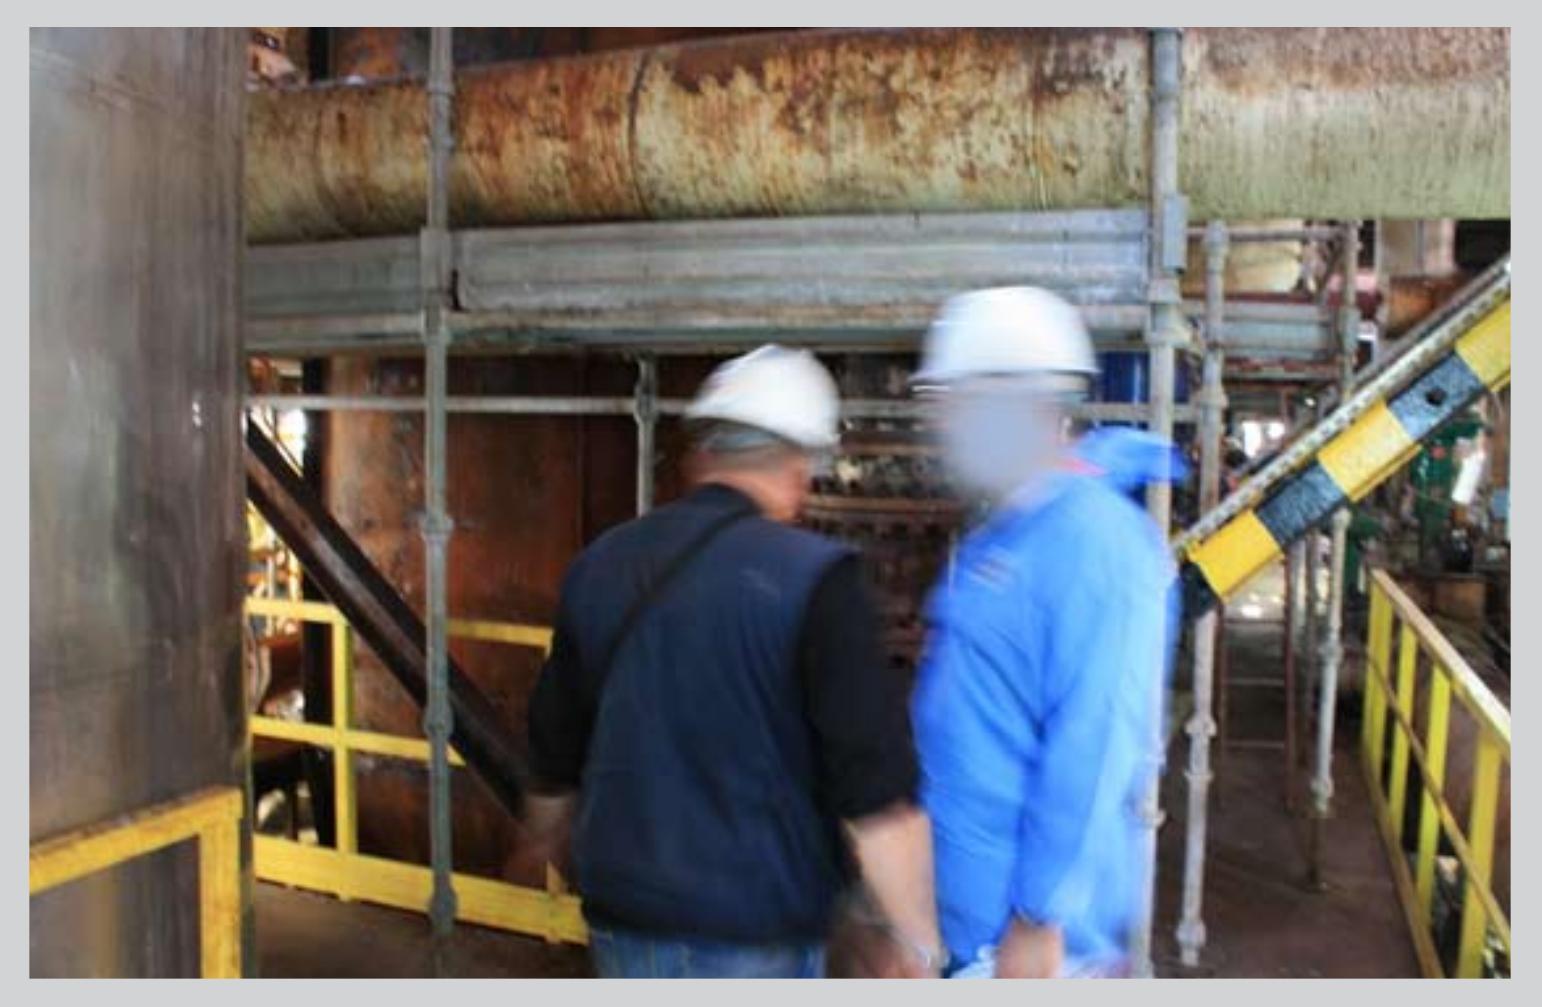
- Silvercladd 800 installed in November 15th, 2011
- No corrosion abserved on any of the Silvercladd inner or outter surface
- Contractor removed the Silvercladd to check for CUI: no evidence for corrosion. Contractor's remark "It looks like the first day we installed it".

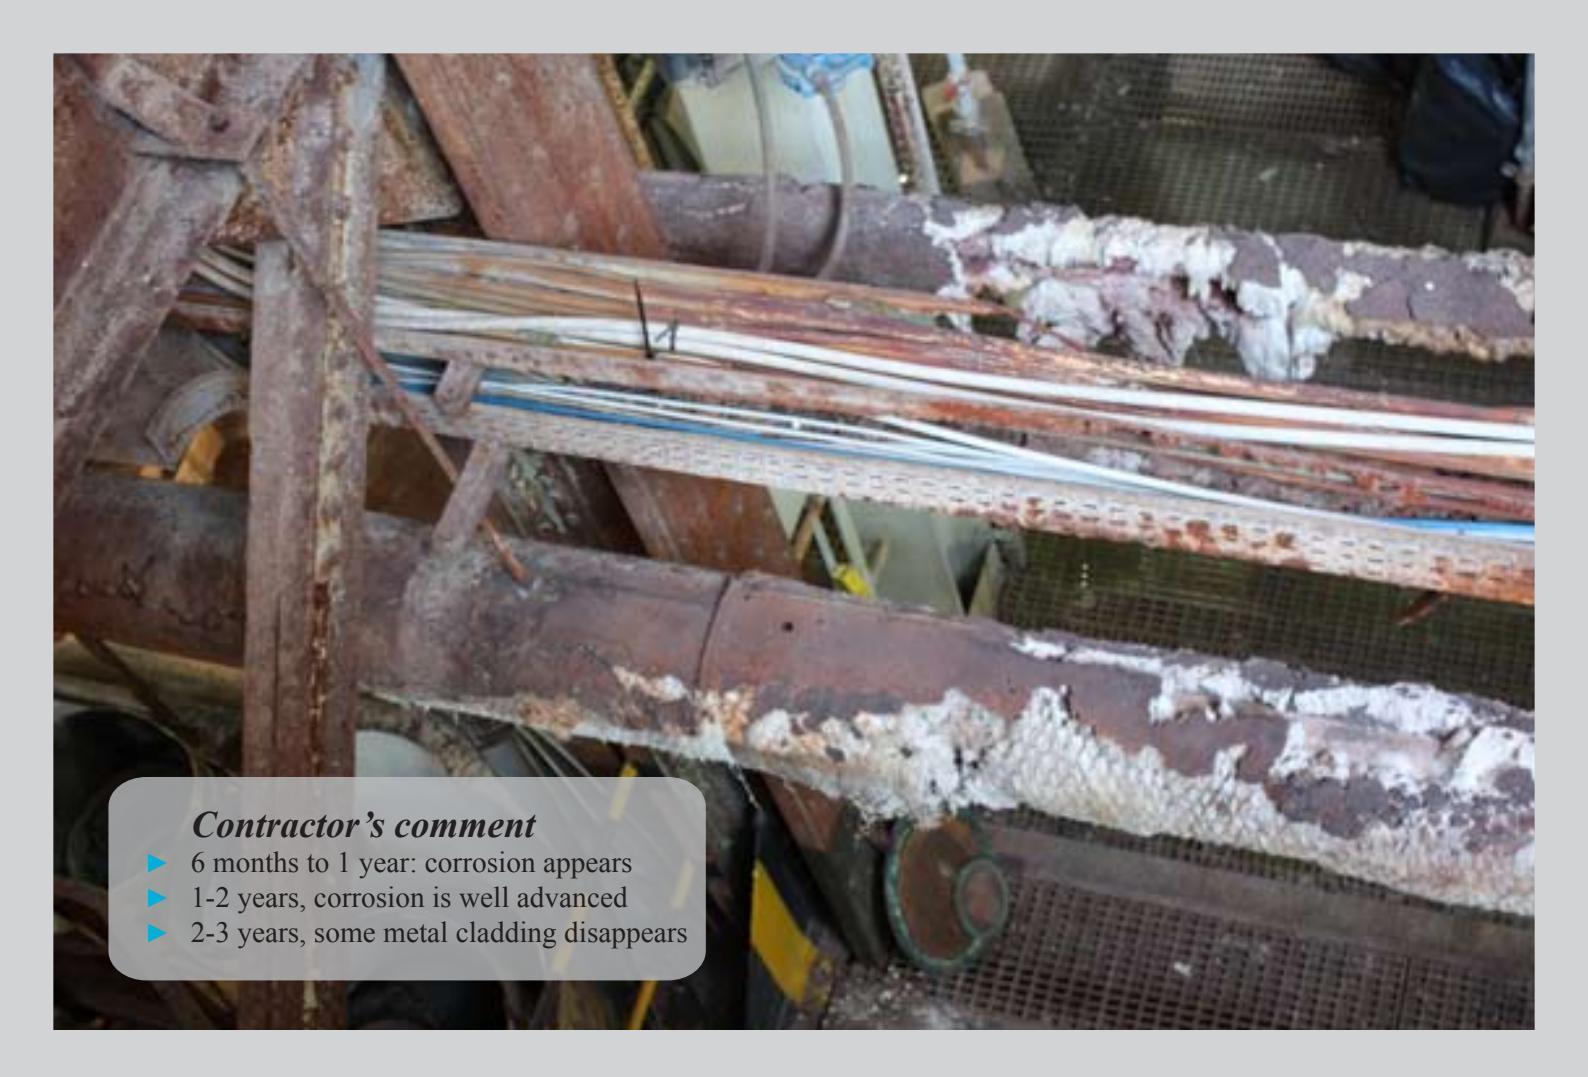
- Above: metal jacket installed about 2-3 years ago
- Bellow: Silvercladd 800 installed over pipe, over 1 year ago
